THE MORRIS MINOR

Where to look for rust.

Introduction

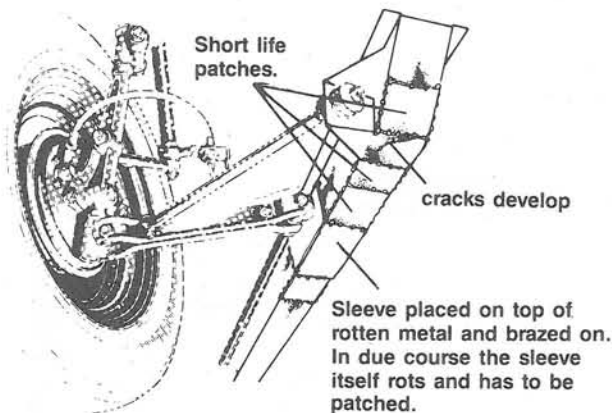
//////
These areas must be structurally sound in order to pass a realistic MOT.

■
Hollow structural pressed steel 'box' sections subject to internal rust.

○
Suspension mounting points.

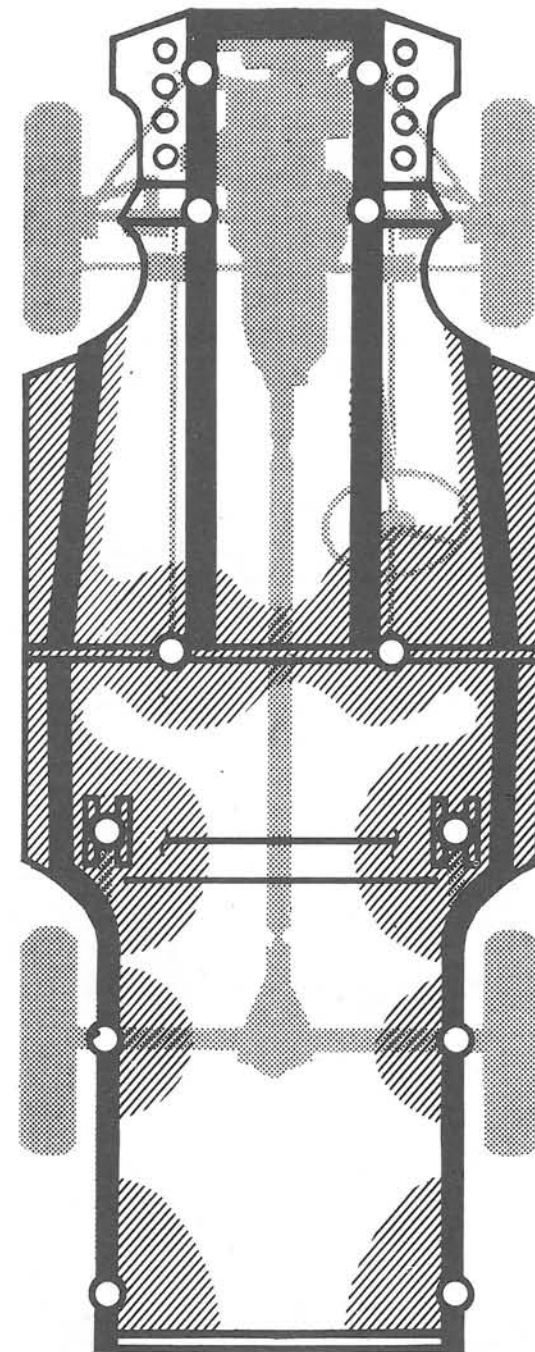
Common areas of rust.

1. Weakness and holes normally covered by the spring mount point. The rear apron also becomes weak and rusty.
2. Rear bump stops around the edges, which causes them to fall off or be patched over.

3. Seam where rear inner wing joins chassis usually weak between rear quarter panel and rear bump stop.
4. Front wheel arch rise (bottom of flich panel) behind and in front of wing.

5. Rusty bottoms of hinge and door shut posts indicates rot in Boxing plates.
6. Four door saloons rot at bottom of shut posts and two door saloons inside the panel 6A (see below).

7. Bottom front corner of rear inner wing.
8. The rear inner wing is usually packed with mud which causes long term rot above the rear spring hanger and along the seam with the bodyshell.

9. Inner quarter panels and adjacent floor areas rot at join with end of crossmember. Crossmember rots from the jacking point inwards, and when hit, metal flakes off the sides, or is holed. The flange (a vertical laminate band of metal welded to the underside of the crossmember) often opens up and forms a wavy profile underneath, letting damp into the laminates.

10. Inner and outer quarter panels and Boxing plates rot from the inside out.
11. Chassis legs and front crossmember rot from inside or as a result of damage not being repaired.

12. Tie plate on the nearside rots as a result of the radiator overflow dripping.
13. Front spring hanger. Rot develops inside the 'shoe' itself hidden by the spring. Cracks in the floor pan develop.

14. Cracks running along the area above the crossmember under the driver's seat, develop if the crossmember is weak.
15. Top of front inner wing in bump stop areas.

16. Joint between flich panel and flich extension often rots away.

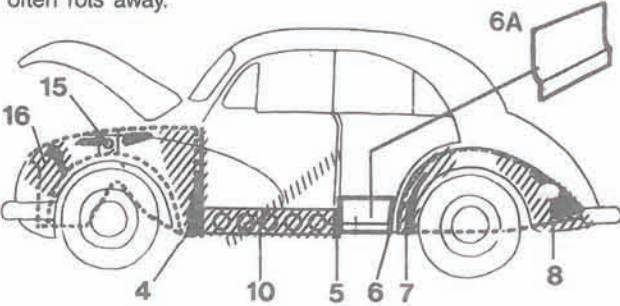
Body — Usual Weak Places.

1. Always look for 'bubbling' paint and signs of scratch marks underneath the paint, in all the areas marked, indicates repair work has been carried out.
 2. Body panels. Commonly filled and repaired areas.
- Materials used. Anything from chicken wire to old cigarette packets, newspaper and of course fibreglass. All rust comes from behind, or in the case of doors wings and bootlids, from inside out towards the surface, so it is no use filling and painting a rusty panel — except as a temporary measure.
- Different variations to the colour will indicate previous repairs if the car has been patched over the years.

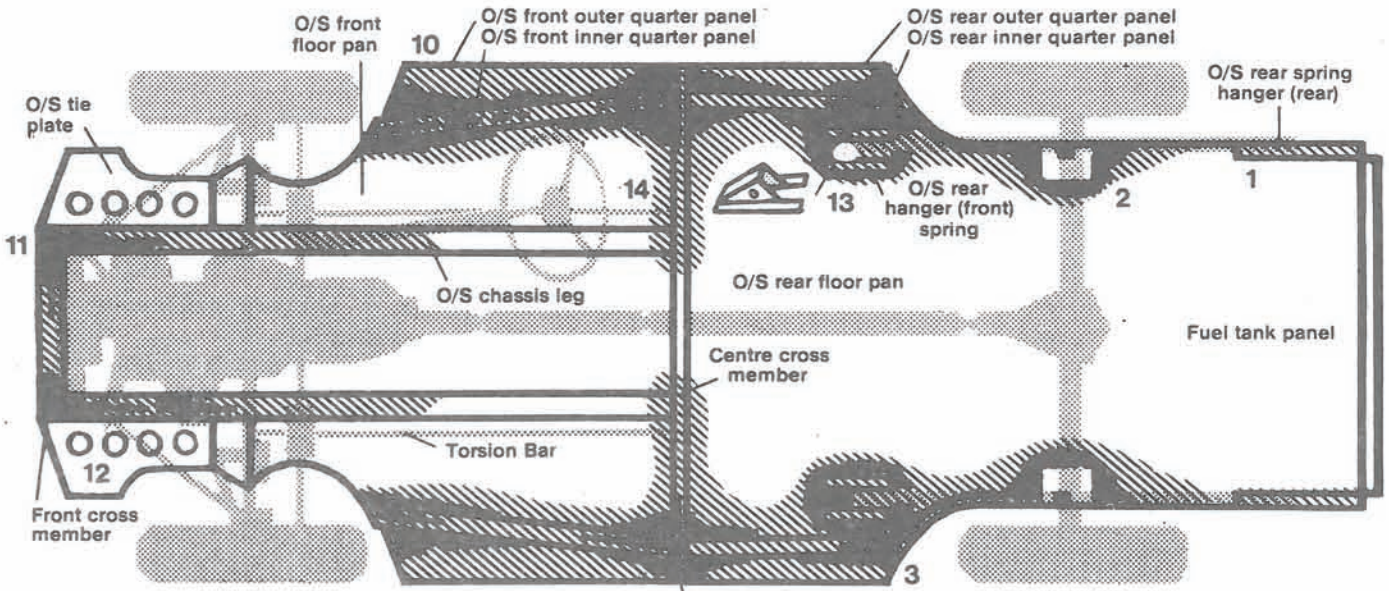
This shows a typical chassis that has not been repaired. The severe rust areas are related to hollow frame.

Bottom flange laminates open up and damp gets into the vertical laminate causing structural weakness.

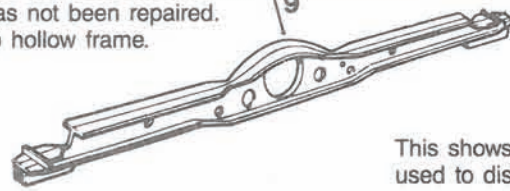
This shows where MOT patches and cover panels are used to disguise the condition of the underbody.
